**CONNECTICUT RIVER BASIN
GLASTONBURY, CONNECTICUT**

**ADDISON POND DAM
CT 00245**

**PHASE I INSPECTION REPORT
NATIONAL DAM INSPECTION PROGRAM**

APRIL 1981

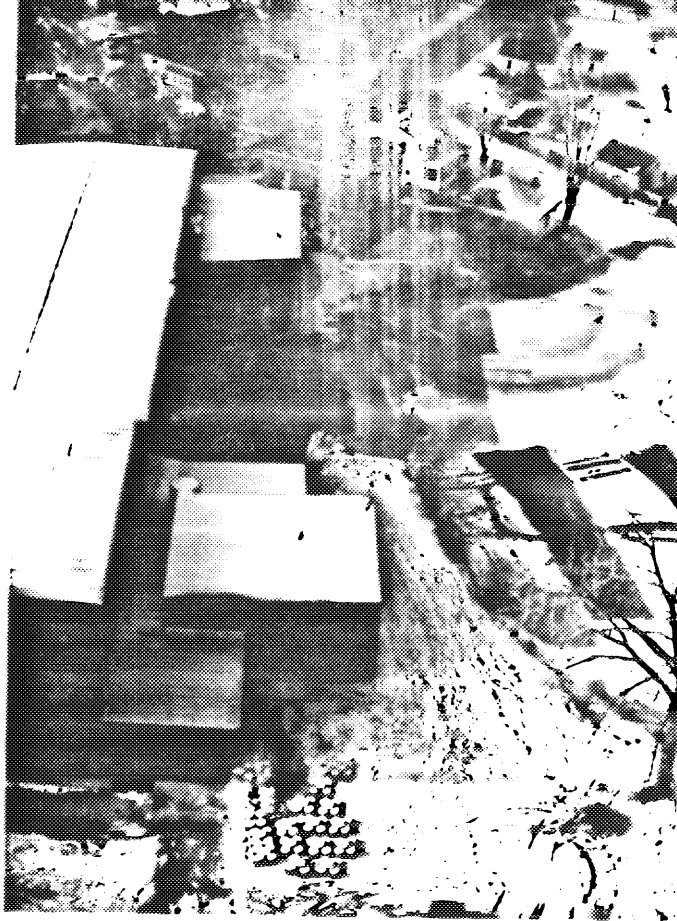
Photo 1 - View of dam and spillway
looking West.

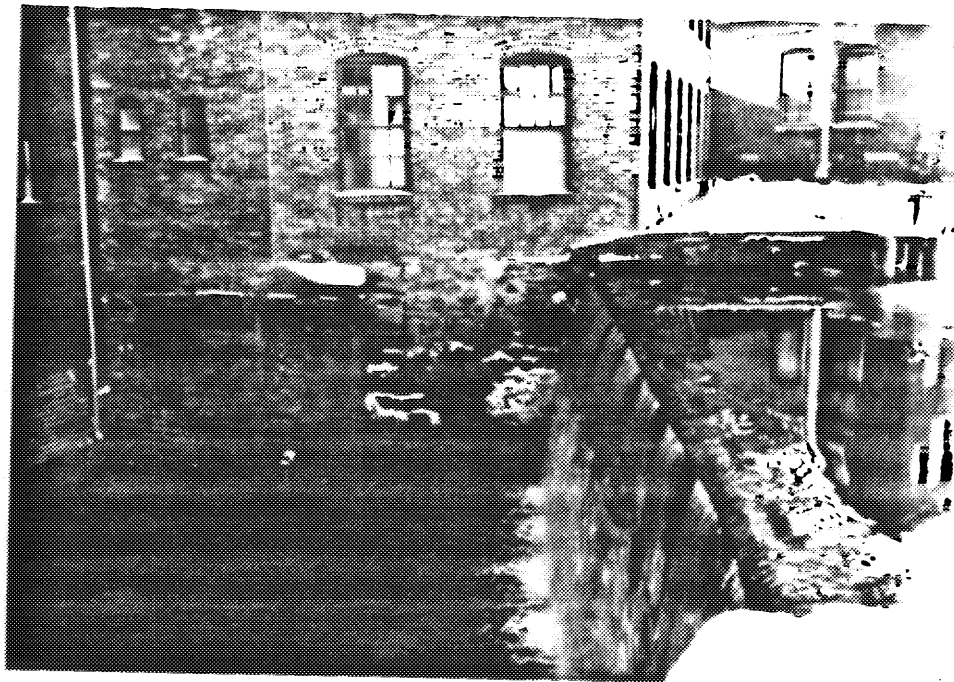
east wall is lacking several stones and its concrete coping, whereas, the west wall is only missing the concrete coping (See Photo 2). Overall, the general condition of the two training walls was good with no evidence of missing mortar or seepage. The approach channel through the training walls and the channel immediately downstream of the spillway was clean with no accumulation of debris (See Photos 3 and 4).

from the stone masonry foundation, through the east face of the building into the downstream channel (See Photo 2). The leakage may have been associated with the intake chamber.

Seepage was also observed flowing from the stone masonry foundation of the warehouse located downstream and west of the spillway. The water leaking between the stones is gradually eroding the mortar which increases the possibility of failure of the foundation. Since the west side of the spillway is attached directly to this structure, failure of the building could

possibly result in dam failure. The source of the water may possibly be the intake chamber situated upstream and west of the spillway. Several pipes ranging from 1" to 12" enter the basement coming from the direction of the chamber. It is quite possible that water is leaking from the intake riser into the basement area and subsequently leaking through the foundation wall. This intake chamber should be filled in and sealed off to prevent water from entering the basement.

Photo 2 - View across spillway. Note
inoperative outlet works on
right. Note seepage through
the wall of the building.

Inspect the dam after the pond has been lowered and investigate the source of leakage through the dam, spillway, and warehouse foundation adjacent to the west side of the spillway;

1. A formal program of operation and maintenance procedures should be instituted and fully documented to provide accurate records for future reference.
2. Replace the missing stones and concrete coping on the east dam embankment and east training wall.
3. Replace the concrete coping on the west training wall.
4. Fill in and seal off the intake chamber situated upstream and west of the spillway.

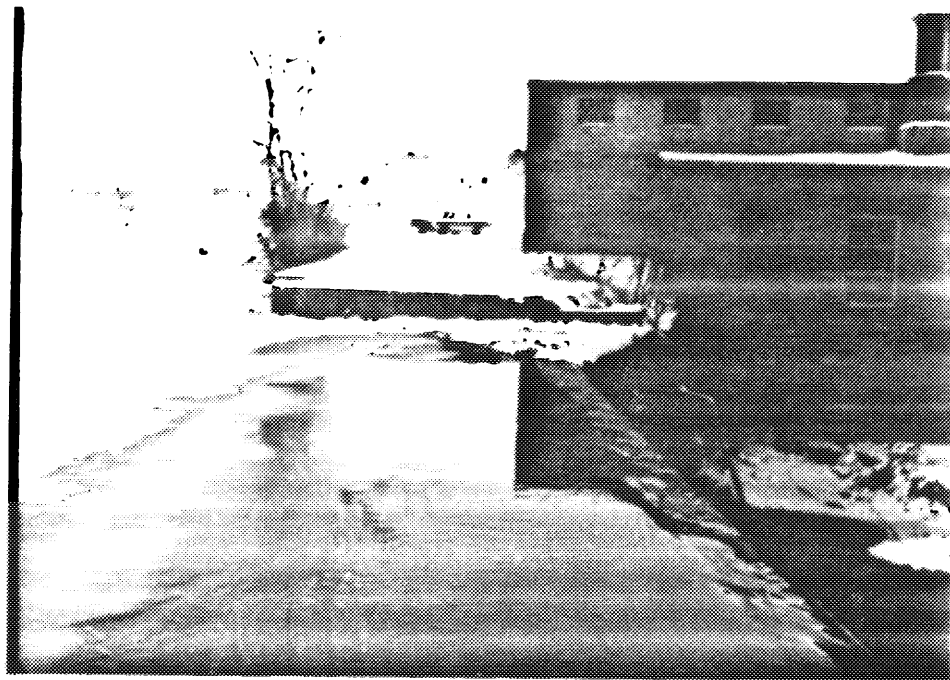
The 50 ft. spillway is a stone masonry structure with a 2 ft. wide concrete coping across the crest (See Photos 2, 3 and 4). Observation revealed leakage all along the spillway between the concrete coping and stone masonry. Due to water flowing over the spillway, a thorough inspection of its face could not be completed.

Photo 3 - View looking across spillway

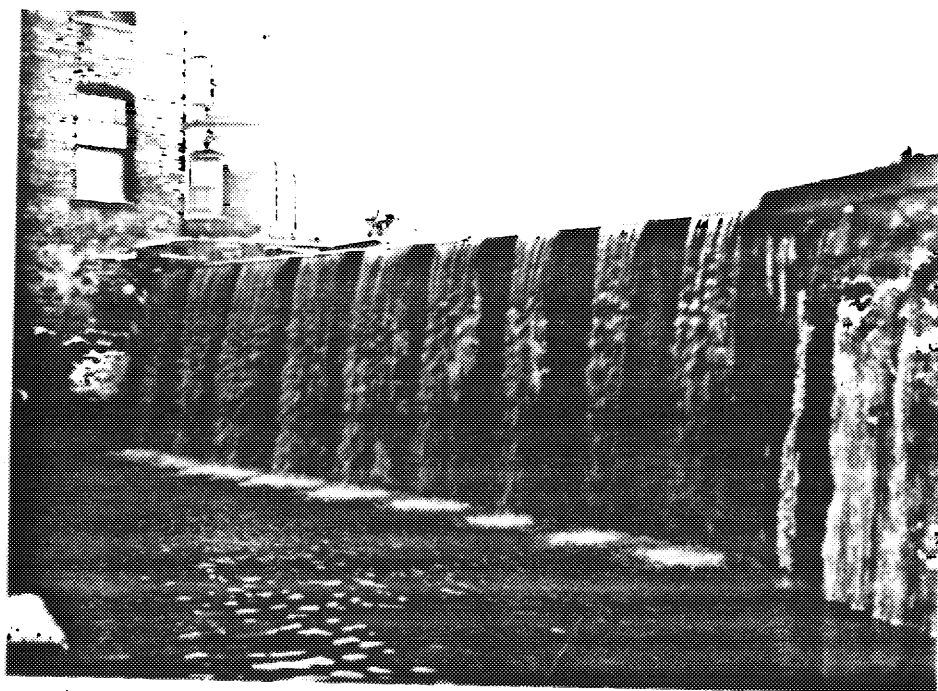
Photo 4 - View of spillway face.

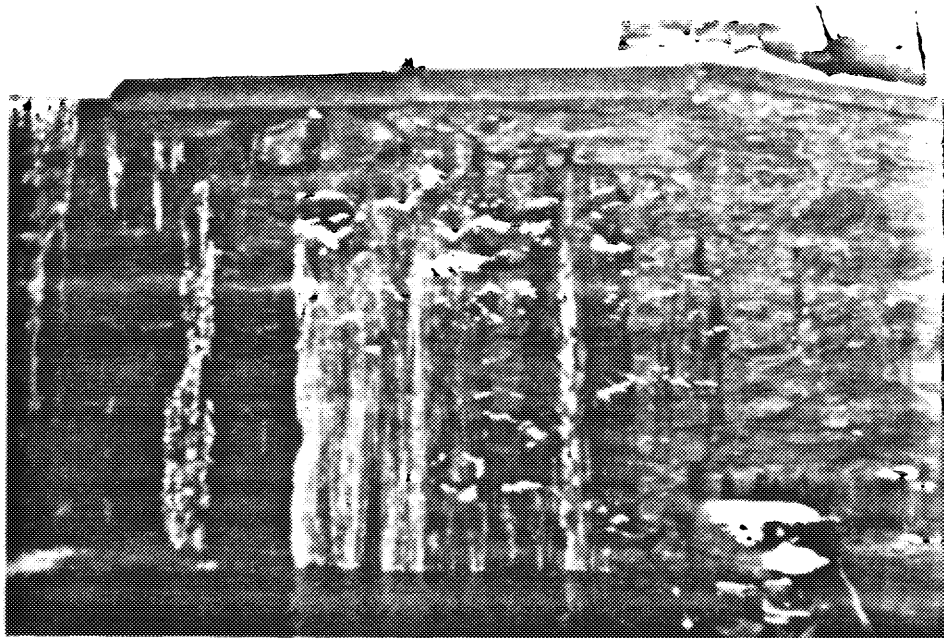
As shown in Photo 6, minor seepage was observed at these mortarless joints and at the contact zone with the rock base. The upper dam section appeared to be in better condition with the exception of the irregular horizontal alignment as a result of several missing stones (See Photos 5 & 6).

Mortar was missing and seepage was observed between the stones at certain areas of the east dam embankment. The continued deterioration of mortar resulting from the seepage will weaken the stone masonry embankment, increasing the possibility of dam failure. At the first five foot length of dam adjacent to the 50 ft. spillway towards the east, water was leaking between the concrete coping and stone masonry which tends to accelerate deterioration of the mortar by flowing down the face of the dam embankment.

Photo 5 - Area of worst seepage through the masonry dam.

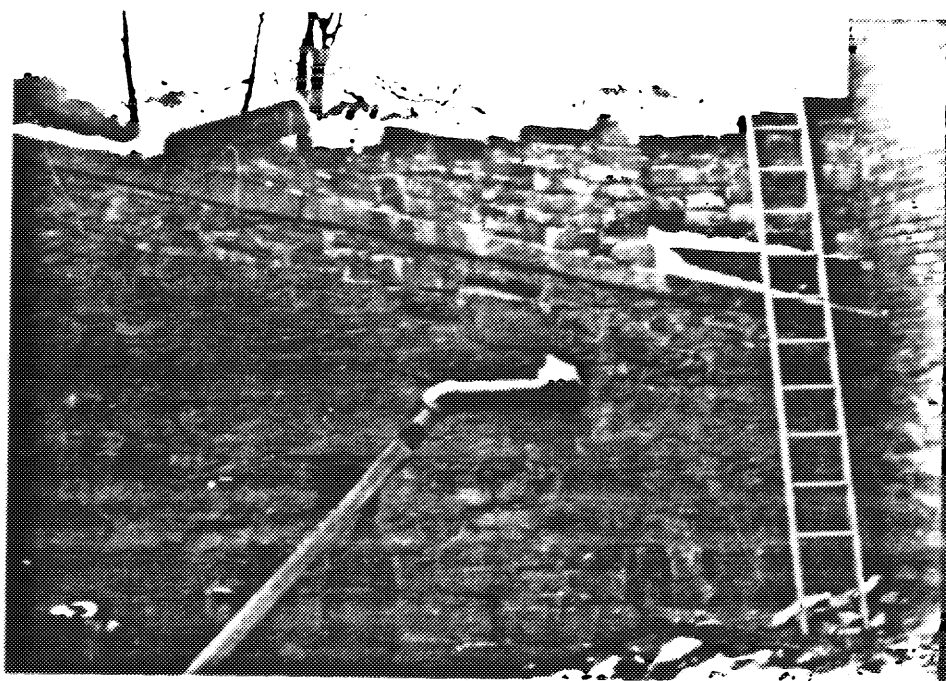
Founded on rock base, the 23' stone masonry east dam embankment was generally in fair condition with an appreciable amount of mortar missing between the stones of the lower two feet.

Photo 6 - Seepage zone at contact of bedrock and masonry (Left of ladder).
Note lack of mortar in joints.

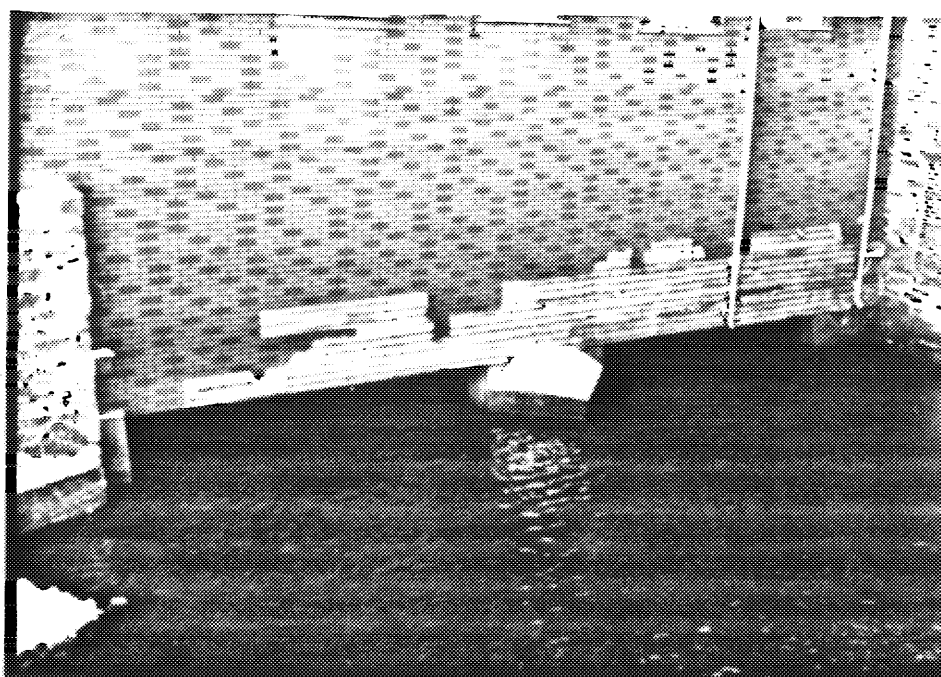
The downstream channel immediately south of the spillway flows under Porch and Patio warehouse, which is supported by timber girders on concrete pedestals. During the inspection of the downstream channel, one pedestal was observed to be displaced and not carrying the girder.

Photo 8 - Channel under warehouse downstream of spillway.
